Mineralogical and physical–chemical characterisation of Roman mortars used for monumental substructures on the Hill of San Antonio, in the Roman city of *Italica* (prov. *Baetica*, Santiponce, Seville, Spain) [☆]

ABSTRACT

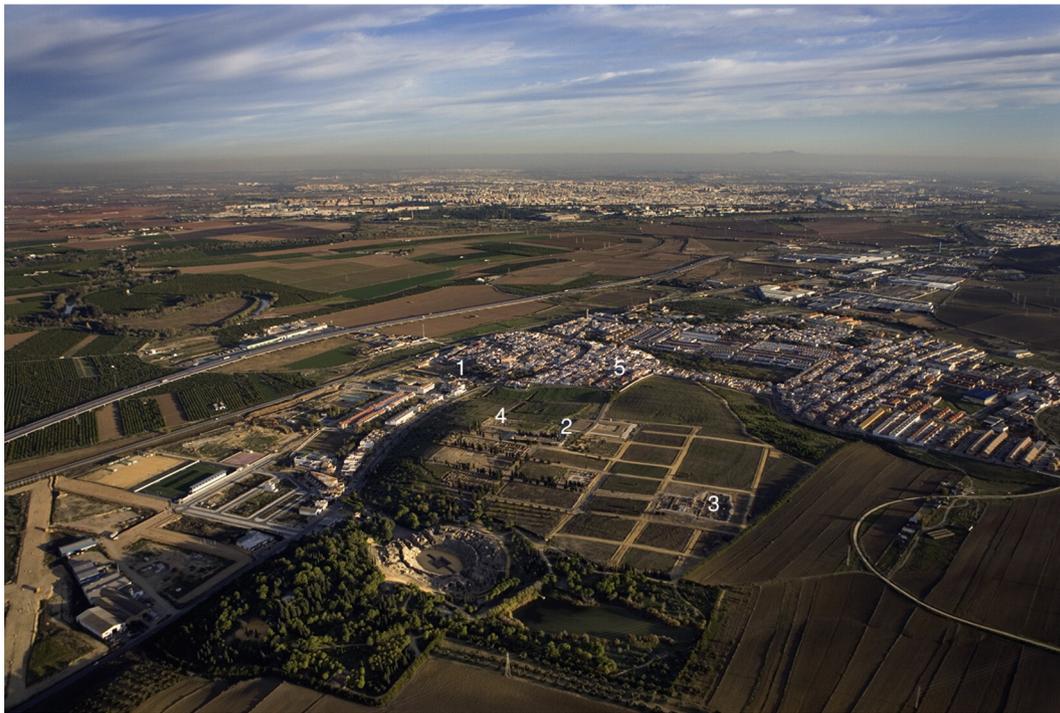
Fig. 1. Aerial view of the Roman city of Italica. The numbers point to the structure which we analyse in this work (1) and other locations cited in text: *tetrapylon* (2), 'greater' baths (3), sewer (4) and 'lesser' baths (5).

This is not the only *opus caementicium* substructure in the city, but it is certainly the largest one that has been preserved. For example, direct observation has also revealed the use of this technique in the so-called 'tetrapylon' (Fig. 1.2), the 'greater' baths (Fig. 1.3), and the sewer that runs beneath the eastern *decumanus* (Fig. 1.4); all have *opus caementicium* walls with the imprint of vertical side-shuttering. All of these structures are dated to the 2nd-century expansion. This technique, although there are considerable differences in terms of material and finish, is also found in the so-called 'lesser' baths (Fig. 1.5), which are traditionally dated to the reign of Trajan (Roldán, 1993, 121–131; Bukowiecki and Dessales, 2008).

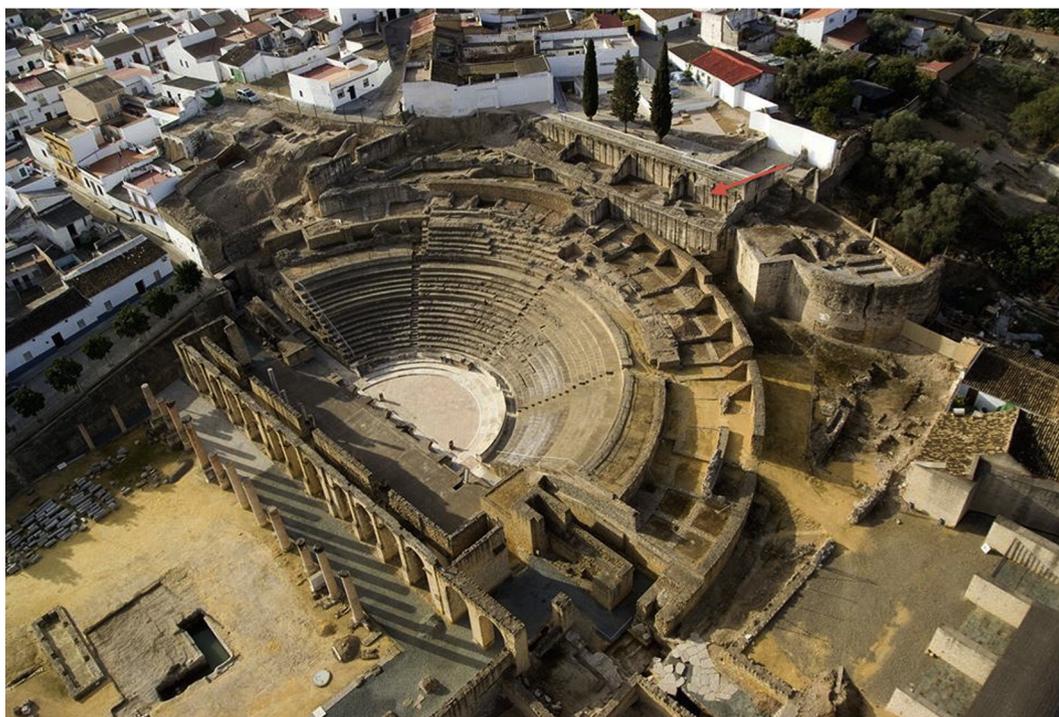
Fig. 2. View of the Hill of San Antonio and theatre, located on its eastern slope. The arrow points to the foundations which are the subject of this work, immediately to the west of the theatre.
