New remarks on the mid-17th-century gunfounding in Northern Europe: archaeometric analysis of scrap bronze ordnance recovered from a Dutch merchant vessel lost off Cadiz, Spain

Abstract

Keywords Bronze guns · Mid-seventeenth century · German gunfounding · Dutch shipwreck · Archaeometallurgy

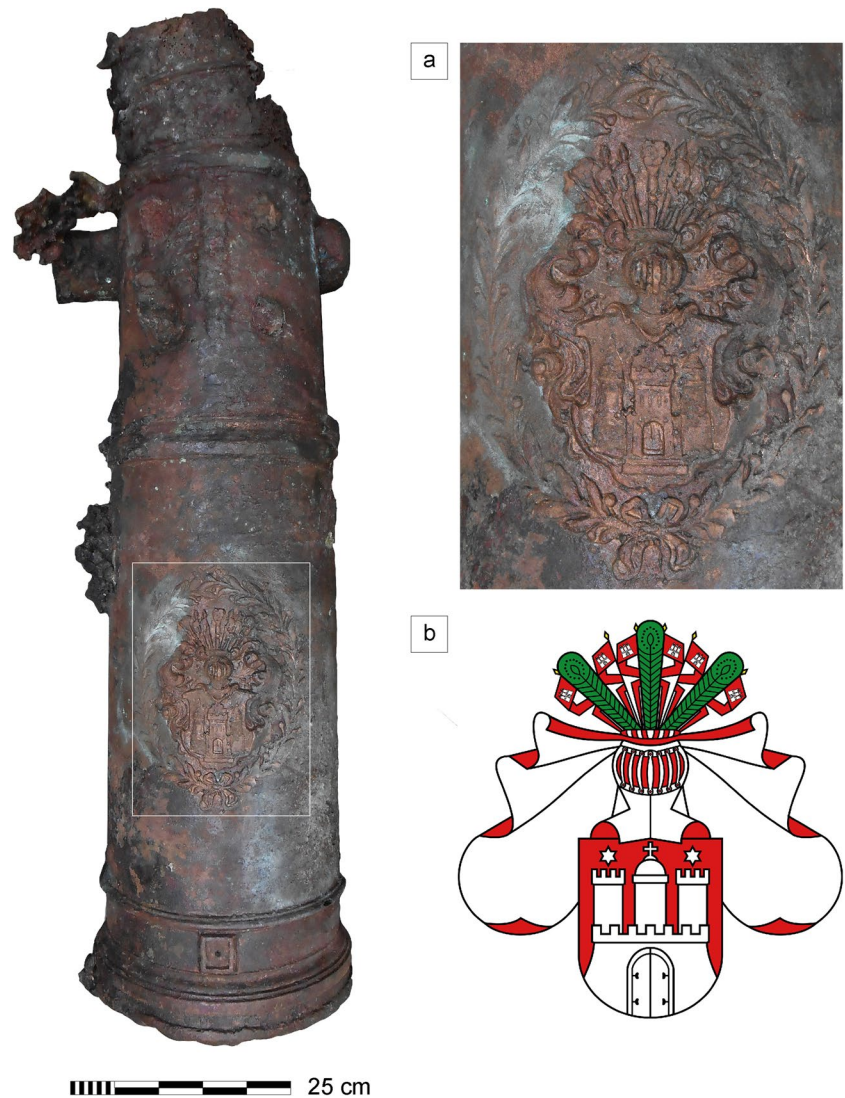
Fig. 3 Image of gun No. DIII-847: **a** detail of the coat of arms; and **b** drawing of the middle coat of arms of Hamburg (Mittleres Wappen der Freien und Hansestadt Hamburg, from: https://www.wikiwand.com/de/Landeswappen_Hamburgs). Image: NC Ciarlo

Gun no. DIII-847 is the largest piece recovered from the site, with a length of 118 cm. The remains comprise about two-thirds of a complete gun: the chase, cascable, dolphins, and right trunnion, are not preserved (broken/miscast). However, the recorded features—some showed by other guns' fragments—allowed us to circumscribe its origin and date. The breech ogee is decorated with a series of acanthus leaves finishing with an accused scroll (pattern no. 1). The touch-hole is recessed in a square-shaped vent pan and an emblem is observed between the vent astragal and fillets and the first reinforce-ring and ogee. The latter encompasses a castle with three towers, with a cross on top of the central one and a Marian star on each side tower; in the upper part, it has a crested helmet, three peacock feathers, six banners of arms, and mantling; and it is all surrounded by olive branches (Fig. 3). This emblem corresponds to one of the variants of the coat of arms of the Free and Hanseatic City of Hamburg

(i.e. middle arms, *Mittleres Wappen*), suggesting the gun was an express order to the city for defence or parade/salute purposes.

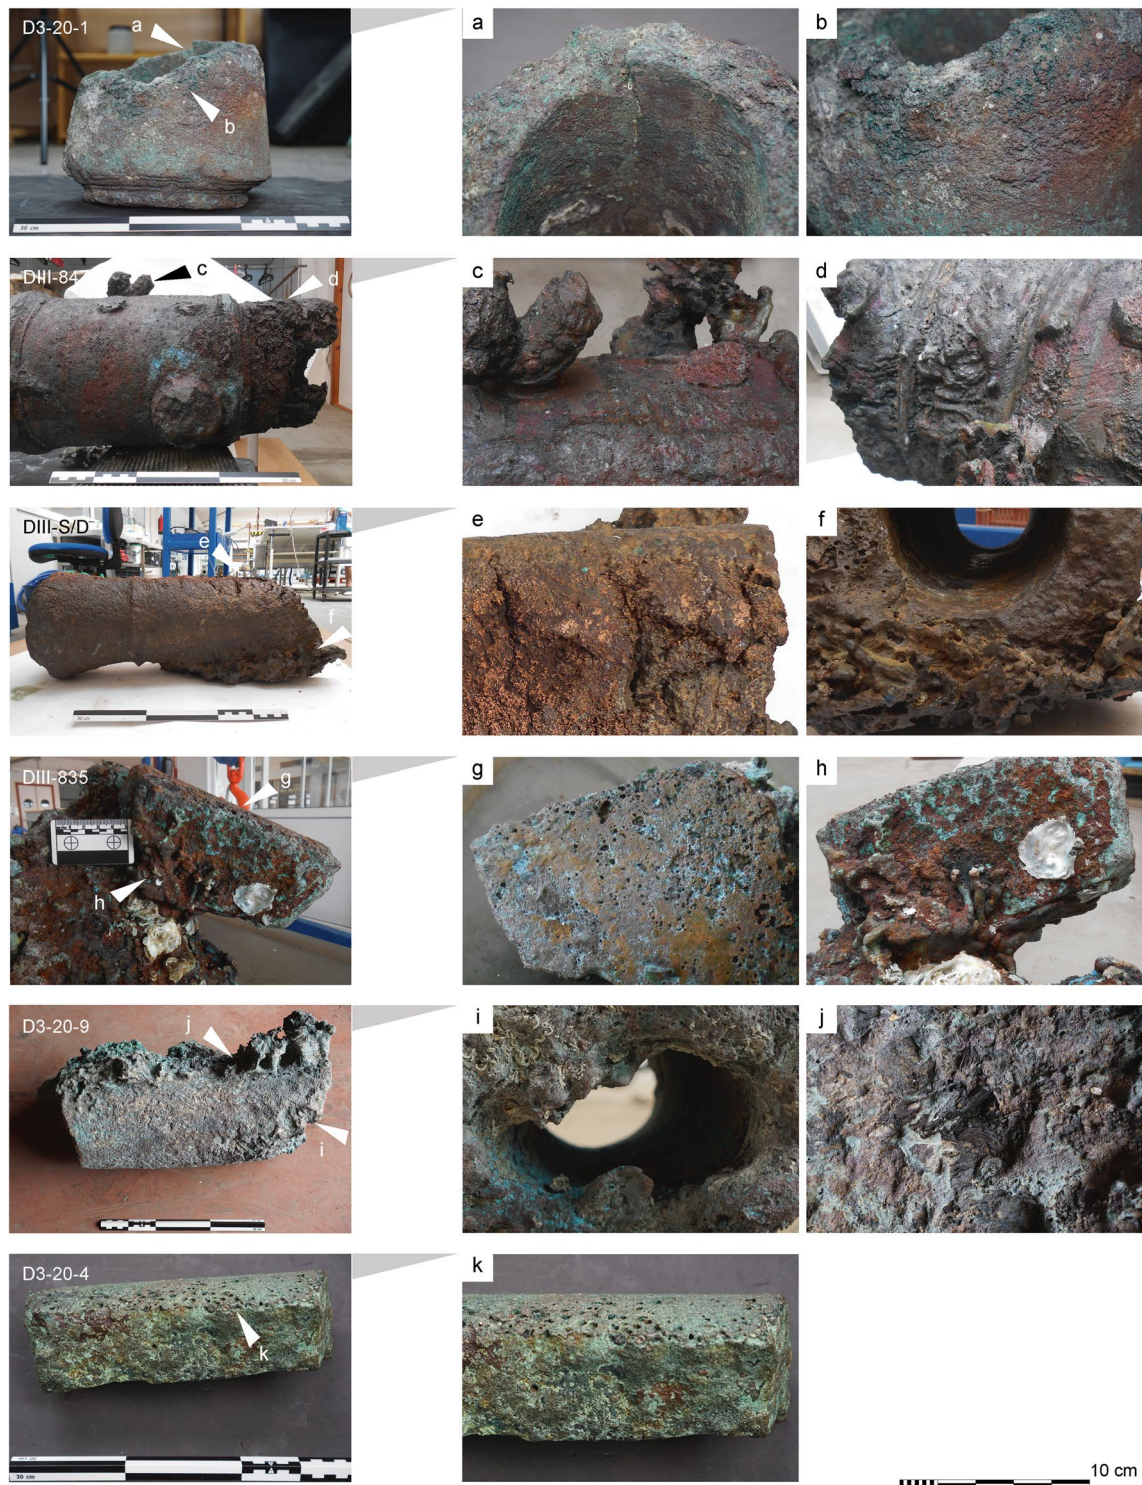
Fig. 6 Macroscopic casting defects observed at the remains surface: **a** cracks: cold tear; **b** sponginess; **c** misrun (unfilled dolphin); **d** vitrification; **e** open shrinkage cavities or pipes; **f** mould collapse; **g** gas

porosity: blowholes; **h** metal drops; **i** deformation; **j** charcoal incrustation; and **k** gas porosity: pinholes. Image: NC Ciarlo

In general, pieces show some degree of porosity, mostly pinholes concentrated at the surface or in a layer just below it. Shrinkage cavities or pipes were also recorded in a few samples. Possible misruns were not seen but in one gun (e.g. dolphins of gun no. DIII-847). Cracks (hot tears⁵ and cold tears) and veining were observed, but they are not common defects. Sponginess (or honeycombing) was also recorded in several gun fragments. Some deformation could be appreciated in barrel fragments as well (e.g. oval-shaped bores). At least one piece also exhibits clear signs of extensive vitrification. Amorphous by-products appear in isolation and as well as welded to guns' parts, usually with encrusted charcoal remains (Figs. 6 and 7). All these features are associated with a failed casting. The microstructural and chemical characterisation of selected specimens provided further data in this regard (see below).

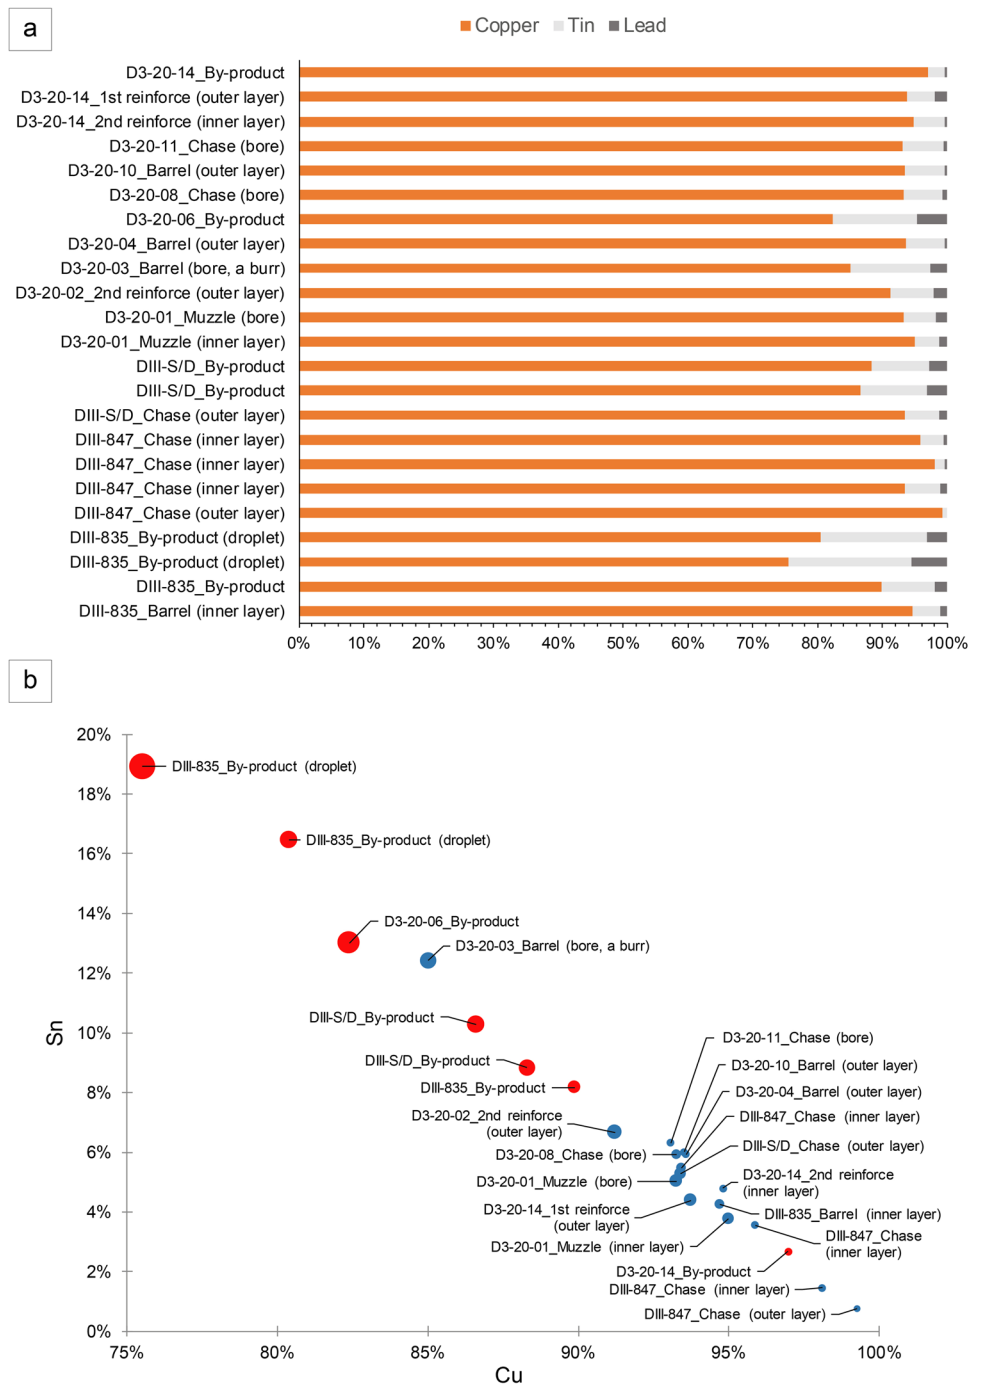
Fig. 11 Mean composition of samples: **a** bar plot of the Cu–Sn–Pb content; and **b** comparison of Cu and Sn of the gun remains (blue) and casting by-products (red); differences in the Pb amount are indicated by the circles' diameter. Images: A. Zuccolotto

The material used to cast the analysed guns was bronze with small amounts of lead. No zinc nor other minor elements were detected. A bar plot and binary diagram of the mean composition of samples depict the proportion of the main elements (Fig. 11). Based on a triangular plot of Cu, Sn, and Pb data, significant differences between gun barrel fragments and

casting by-products were observed, with a certain degree of overlapping. Moreover, as expected, the compositional range of gun remains shows a comparatively lower dispersion of values (Fig. 12). The similarities in the composition of gun nos. D3-20-04, D3-20-10, D3-20-8, and D3-20-11 are noteworthy; the latter two, in particular, show the same decorative pattern.

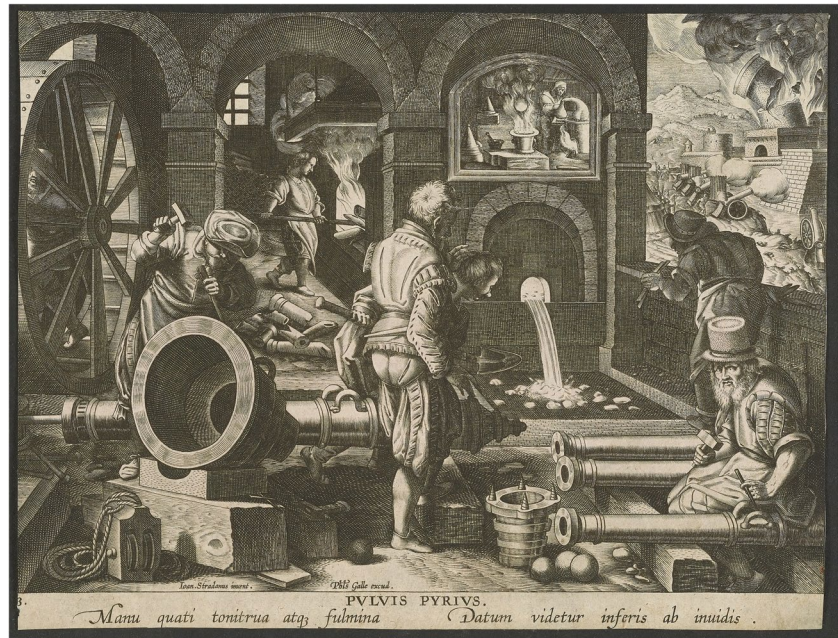
Fig. 17 A Renaissance view of the interior of a gun foundry: Pulvis Pyrius (Invention of Gunpowder), plate 3 from *Nova Reperta*, based on a design of Flemish artist Jan van der Straet, known as Johannes Stradanus (1523–1605), and later engraved by Philip Galle for the print series, ca. 1580–1605. Courtesy of the Smithsonian Libraries and Archives (ID: SIL-nouareperta00stra_0009, <https://library.si.edu/image-gallery/110721>)

A late sixteenth-century engraving depicting the interior of a foundry provides a snapshot of the various activities related to gunfounding. One, in particular, attests to the recycling of old bronze. In the background, through the middle arch, a man is melting down parts of broken guns which were hoarded in a pile near the furnace (Fig. 17).
